9 Valleys Wildlife Corridor Project

Property Site Inspection

1611 Martindale Road, Martindale

Date: November 2016

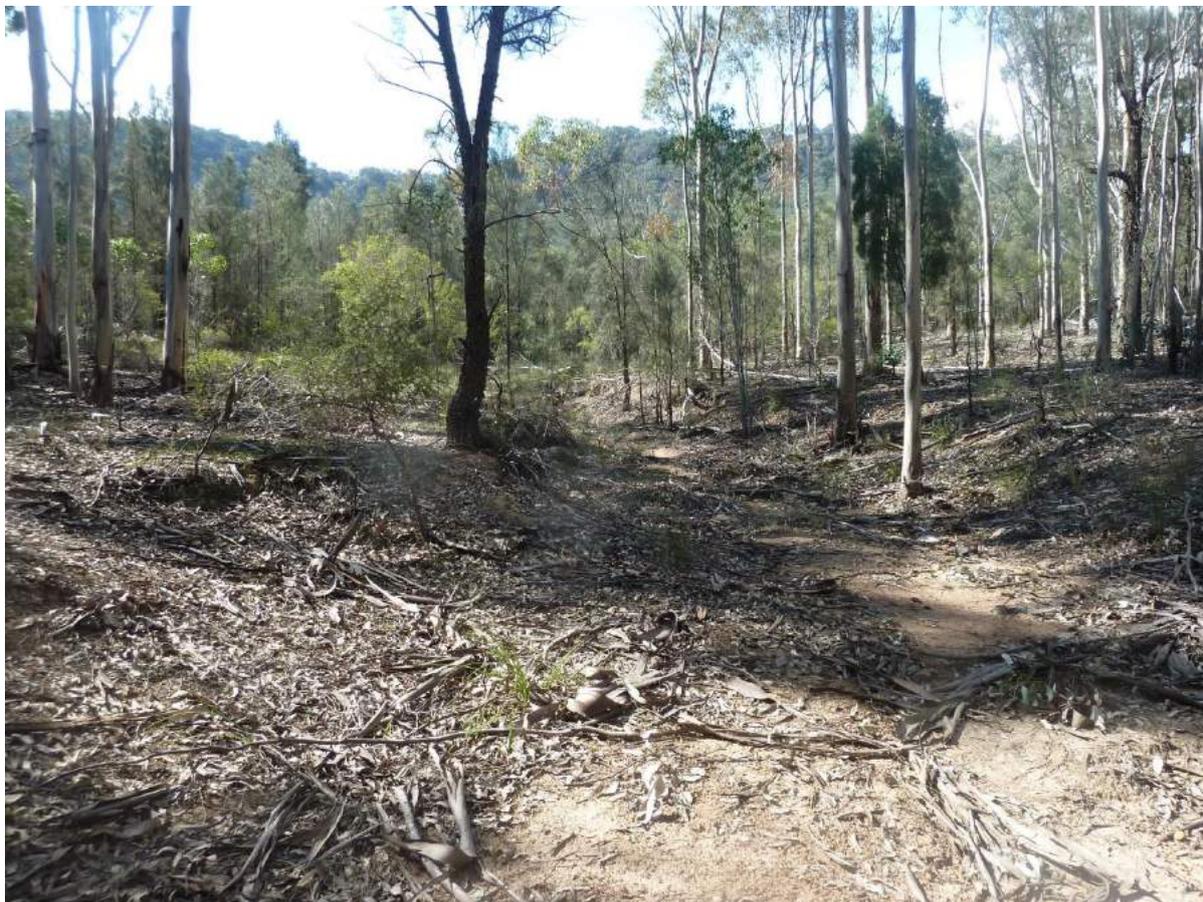
Fallen logs and debris were also evident within the riparian zone along Drainage line 2 (Area 3). There is minimal vegetation along sections of the riparian zone. *Eucalyptus dawsonii* is dominant in this area and naturally generates woody excessive woody debris and can potentially prevent other species from recruiting.

Photograph 1 - Area 3 – Riparian Zone, evidence of woody debris and fallen logs suitable habitat for ground dwelling mammals.

As one of the activities, the landowner is involved in thinning out *Eucalyptus dawsonii*, to encourage native regeneration of other species. Long-term monitoring of this site is also being undertaken.

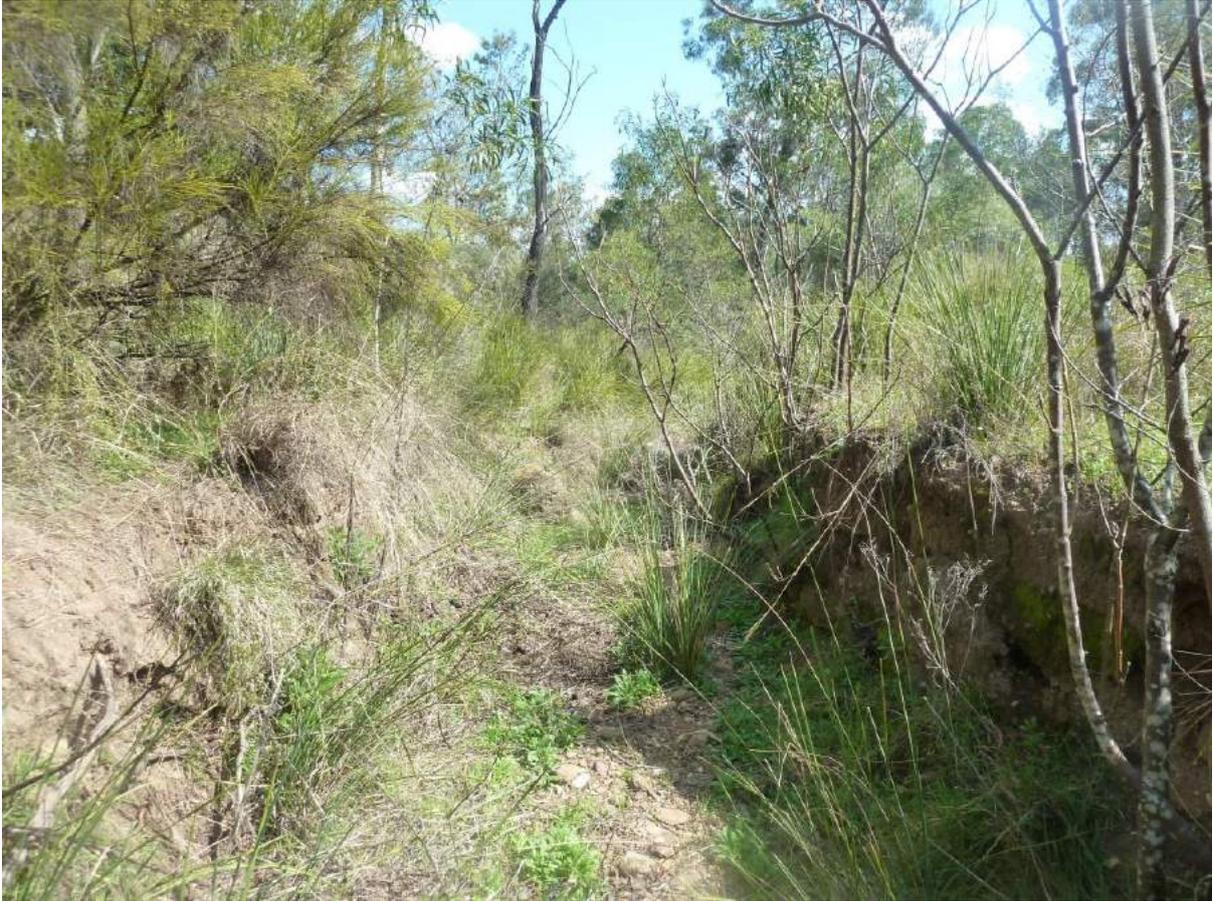
This site has been experiencing continued gully erosion of the drainage line following severe rain or flooding events. The gully erosion increases every time there is rain event. As a result the water flow and volume also seems to be increasing with each event. There is concern that the embankment upstream will eventually collapse.

Photograph 2 – Evidence of gully erosion

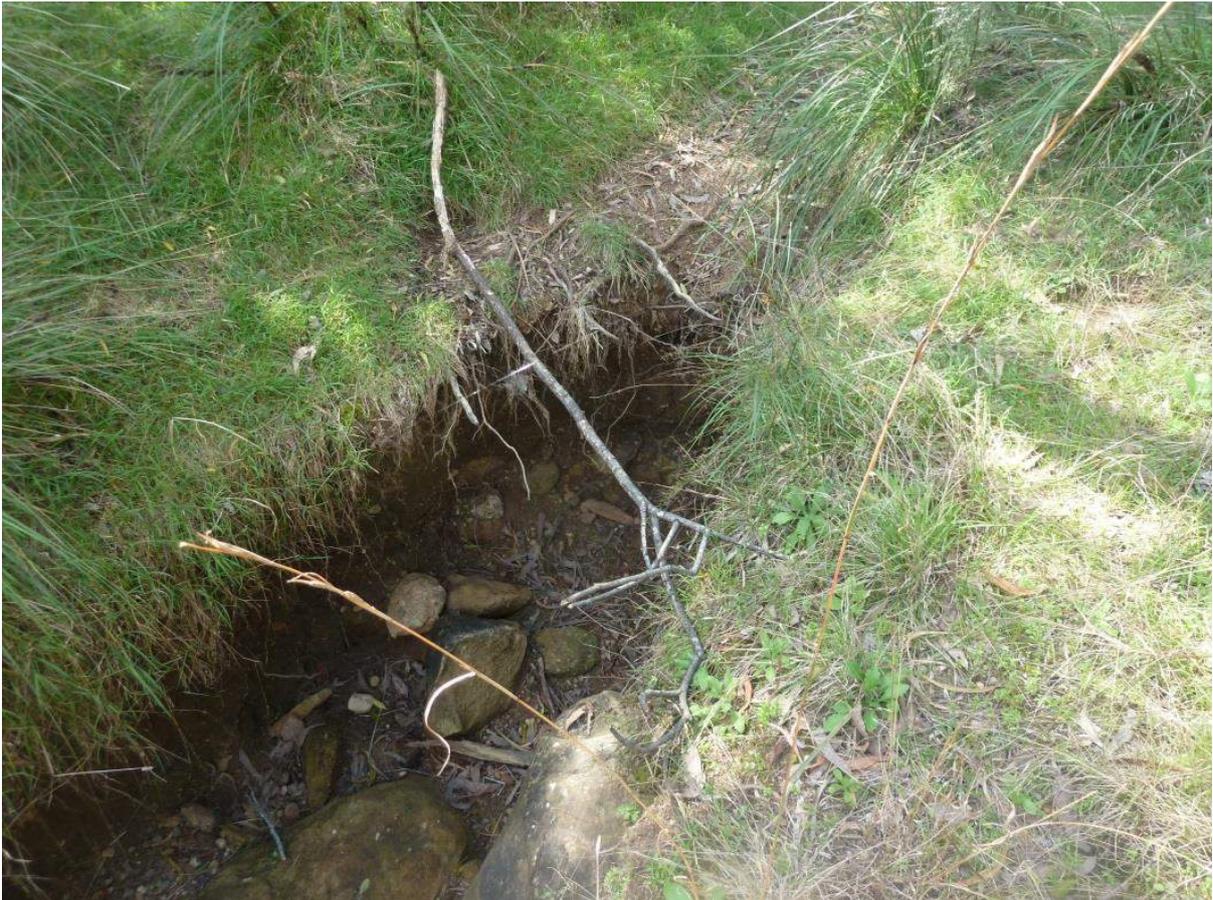
Photograph 3 – Evidence of gully erosion up stream

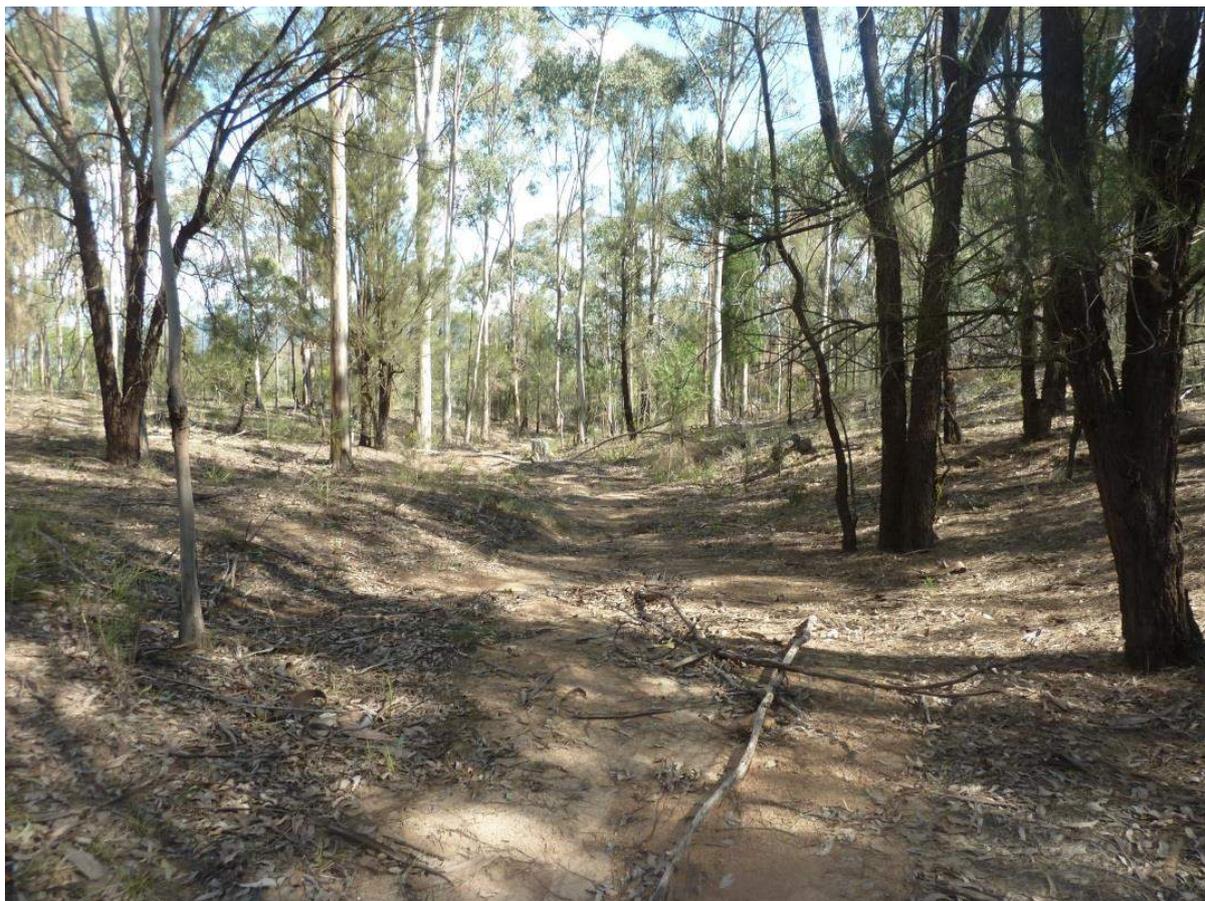
The riparian zone is slowly widening after each flooding event and also the creek bank is being washed down hill, preventing germination of native species. There is concern about the extent of erosion and lack of native vegetation, which in turn will cause the creek bank to further erode following future rain events.

Photograph 4 – Evidence of erosion downstream

Following severe rain events along drainage line 2 (Area 3) soil, debris and logs are washed downstream limiting opportunity for native species recruitment and increasing soil erosion. A number of options to address bank erosion and increase recruitment of native species include:

1. Installation of erosion control measures i.e. appropriate erosion matting that will enable stabilisation of slopes, native seed retention and natural regeneration e.g. Coir matting or jute matting
2. Contact the Department of Primary Industries (Water) for specific advice relating to creek bank and gully erosion
3. Plant appropriate endemic species to further stabilise the creek bank in areas where there is no evidence of natural regeneration.
