# 9 Valleys Wildlife Corridor Project

Property Site Inspection

1971 Martindale Road, Martindale

Date: November 2016

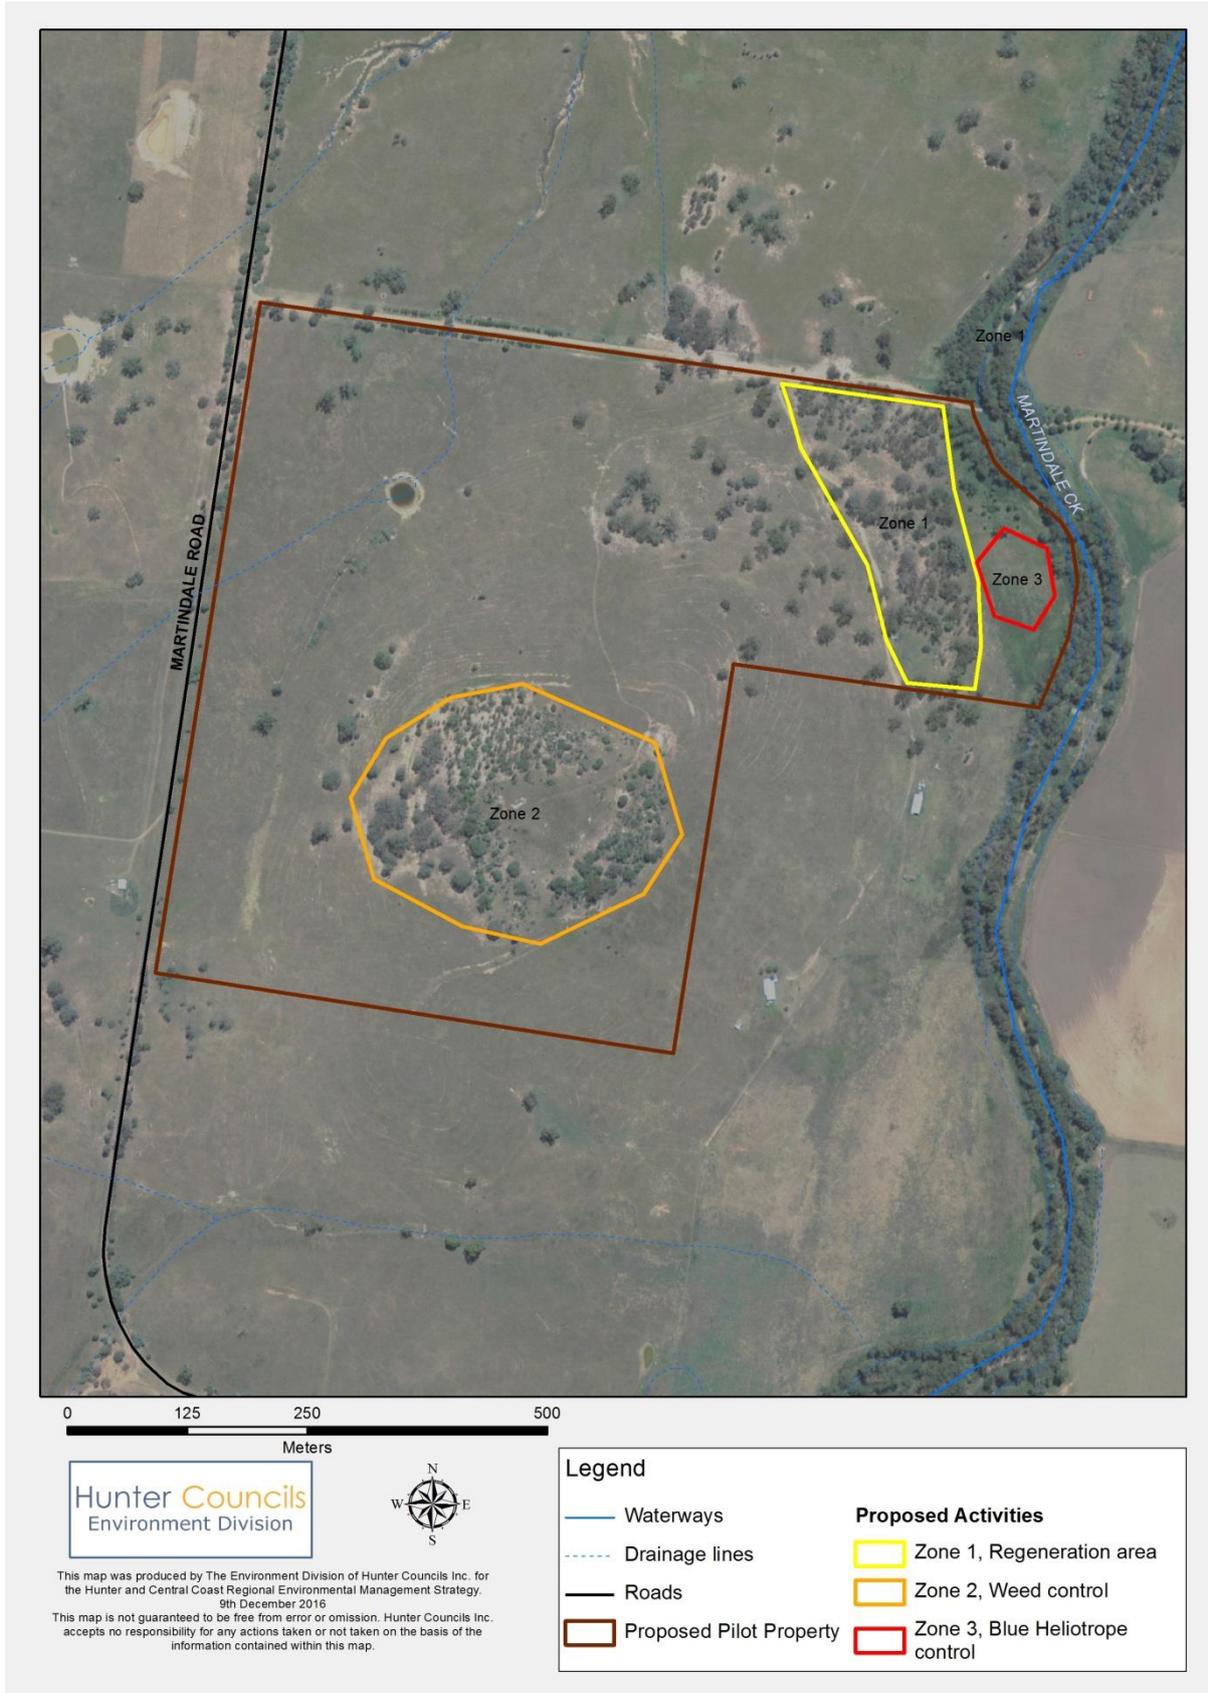
**Map 1: Proposed on-ground Activities**

The property is 63 hectares, which includes approximately 375m of Martindale Creek frontage along the eastern boundary of the property. The property is 80% cleared and is actively used for breeding horses. The property contains a number of small vegetation patches including (refer Map 1):

**Zone 1** – Riparian area containing remnant native vegetation

**Zone 2** – A small patch of native vegetation along a steep and rugged slope to the north eastern corner of the property.

**Zone 3** – A small hill containing remnant native vegetation covering a 6 hectare area located to the southern side of the property.

**Zone 4** – Regeneration area to the north east of the existing dwelling, which horses' access.

Following are details of the management priorities identified during the site inspection. The location for each of these actions is detailed on Map 1.

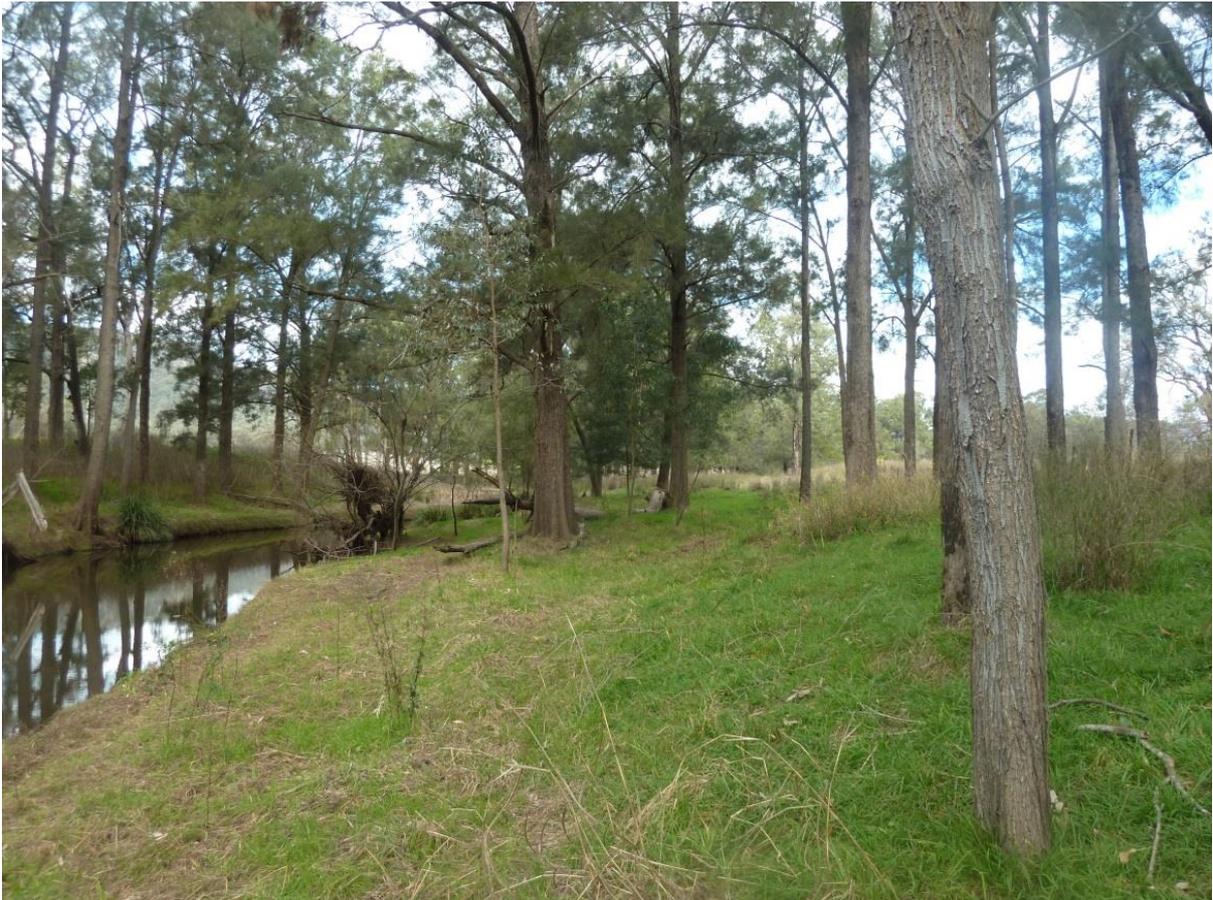
**Photograph 1:** Site of Grey-crowned Babbler along the creek bank

Grey-crowned Babblers (listed as Threatened Species under the NSW *Threatened Species Conservation Act*) were observed foraging within the riparian zone (Zone 1).

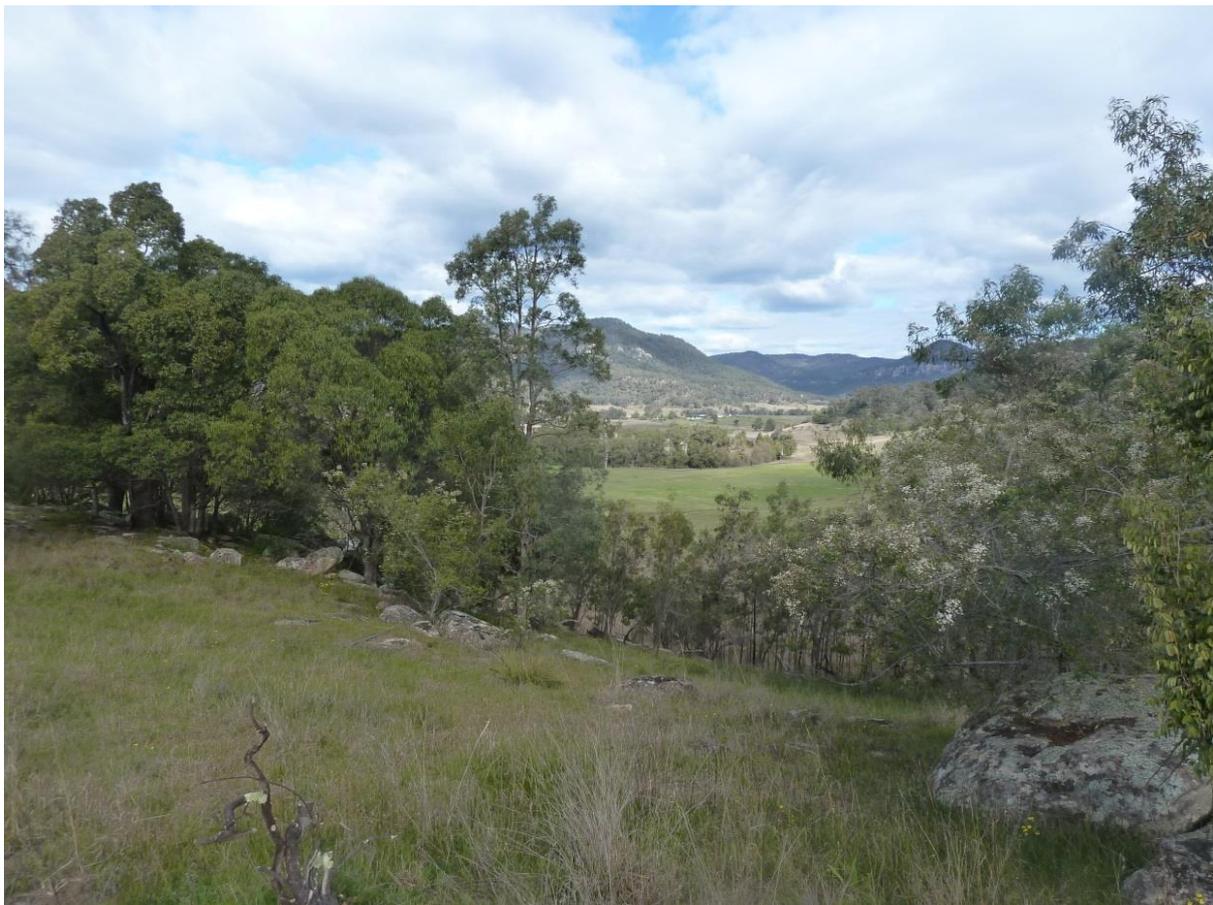
**Photograph 2:** Remnant native vegetation within Zone 3
